# GPS ROLLOVER ALERT

### OmniSat-1 GOES Transmitters – Design Analysis and Vaisala

# Addendum to: GPS ROLLOVER ALERT for OmniSat-1 GOES Transmitters Design Analysis and Vaisala (10/17/2022)

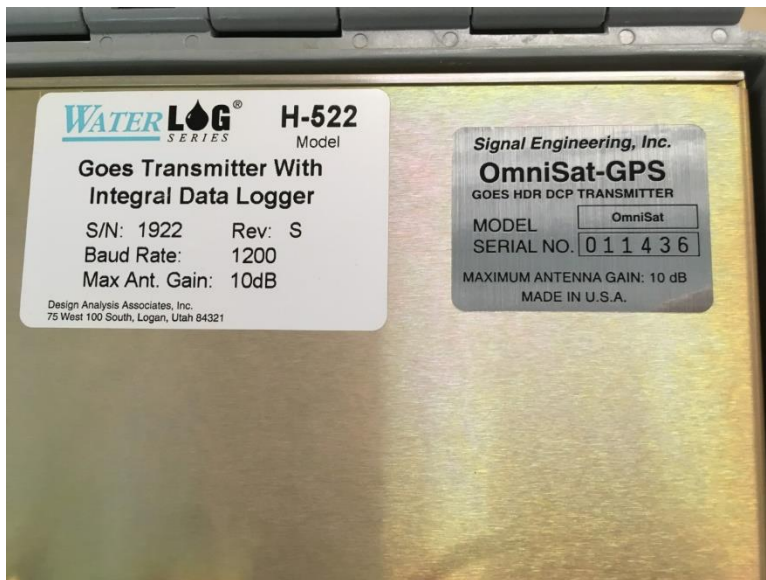
OmniSat-1 transmitters may have labels that say “OmniSat-GPS,” and the picture (below) shows SERIAL NO. 011436, puts that transmitter in Group 3 (where the GPS WNRO will occur on July 6, 2025). “OmniSat-GPS” was a Signal Engineering type designation.
